Home Inspection Report

Sample, Sample, OH 44092

Saturday, January 8, 2022

Icon Home Inspectors

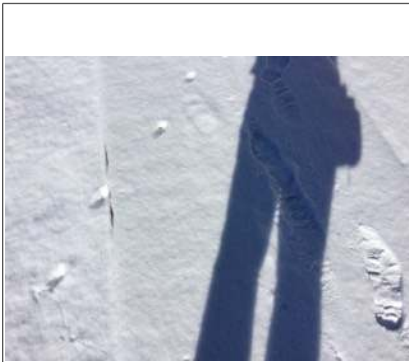
Due to the ground being covered with snow not able to compete a full inspection.

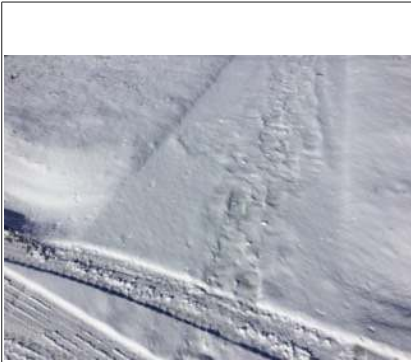
Due to the ground being covered with snow not able to complete a full inspection.

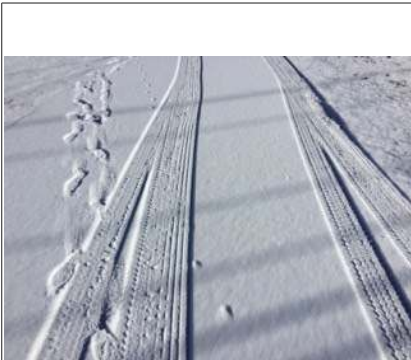
Due to the ground being covered with snow not able to compete a full inspection.

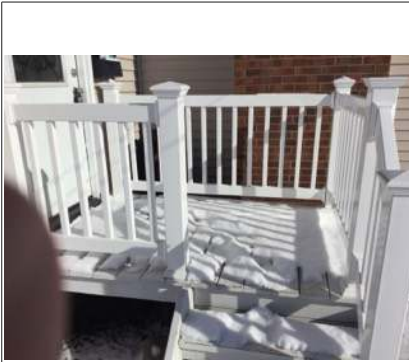
Due to the ground being covered with snow not able to complete a full inspection.

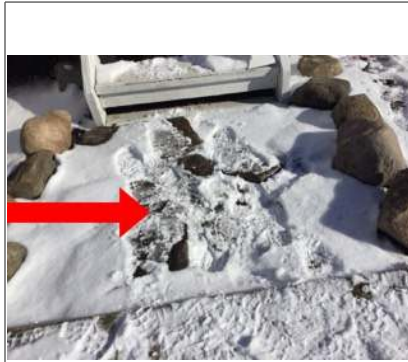
Safety hazard ground is not level, needs to have a contractor repair/replace

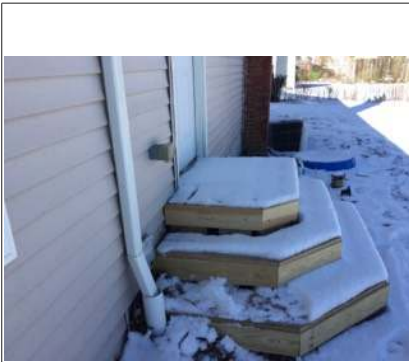
Due to the ground being covered with snow not able to complete a full inspection.

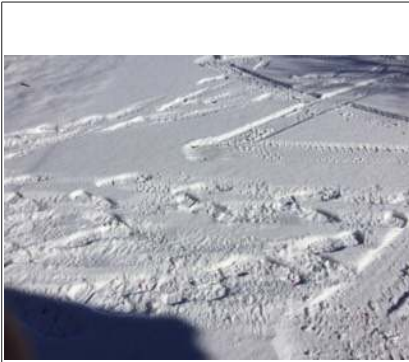
Due to the ground being covered with snow not able to complete a full inspection.

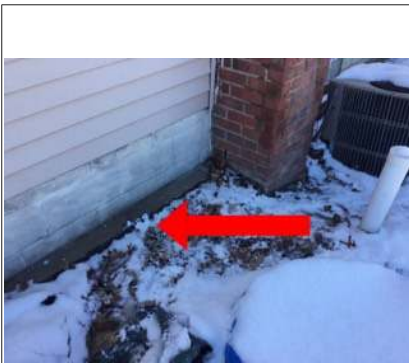
Low areas of grading next to the foundation recommend adding additional soil and slope away from foundation

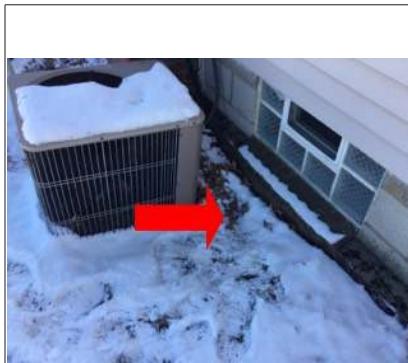
Low areas of grading next to the foundation recommend adding additional soil and slope away from foundation

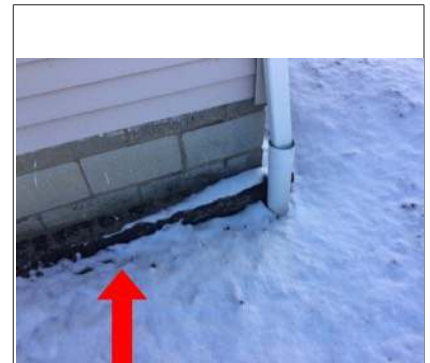
Low areas of grading next to the foundation recommend adding additional soil and slope away from foundation

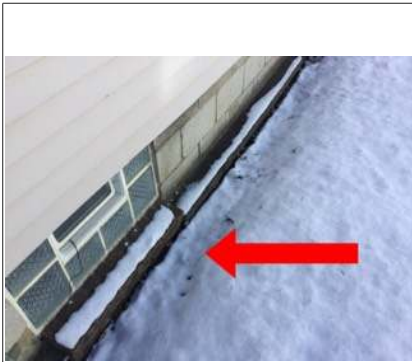
Low areas of grading next to the foundation recommend adding additional soil and slope away from foundation

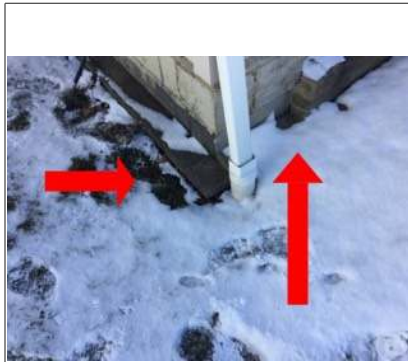
Low areas of grading next to the foundation recommend adding additional soil and slope away from foundation

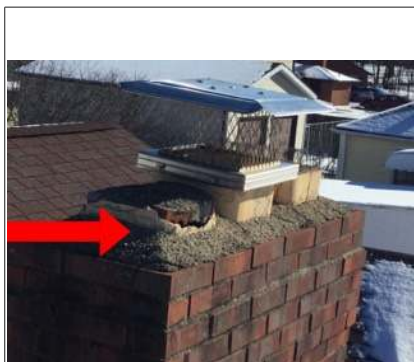
Chimney crown is loose - recommend licensed contractor repair

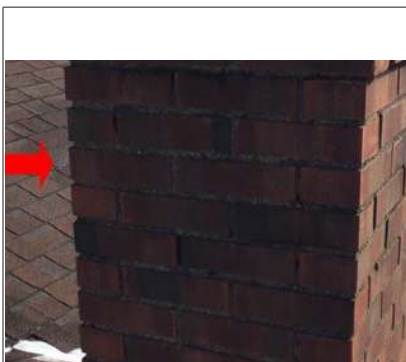
Loose bricks or stones create a safety hazard recommend repair by a qualified chimney specialist

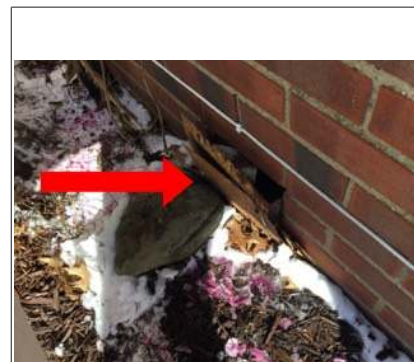
Clean out rusted and needs replaced by a licensed contractor.

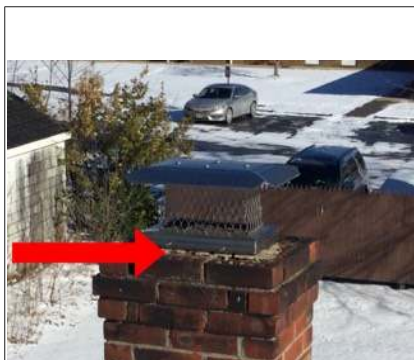
Chimney crown is loose - recommend licensed contractor repair

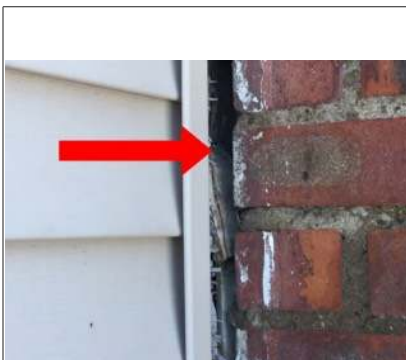
Flashing has pulled away from the chimney - recommend repair

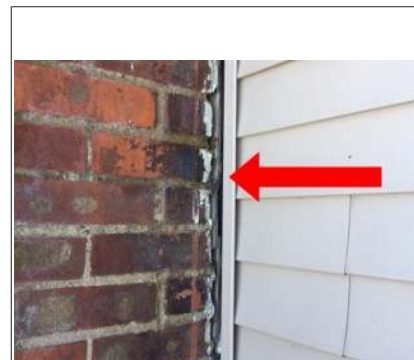
Flashing has pulled away from the chimney - recommend repair

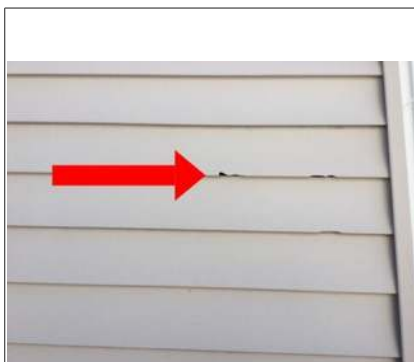
Small cracks in siding needs repaired/replaced

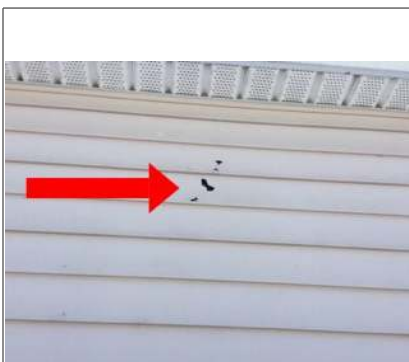
Small cracks in siding needs repaired/replaced

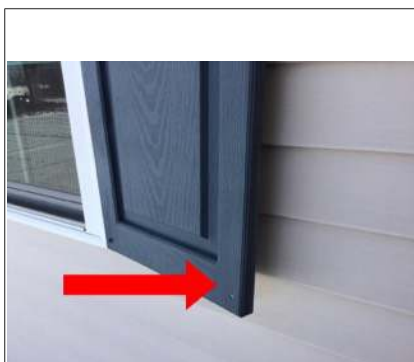
Loose needs fixed

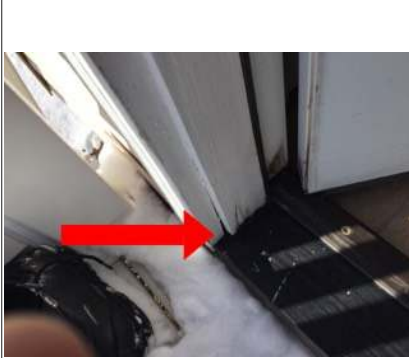
Front door needs painted to prevent wood rot.

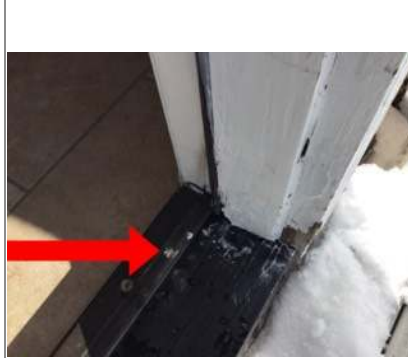
Back door threshold needs repaired by a licensed contractor.

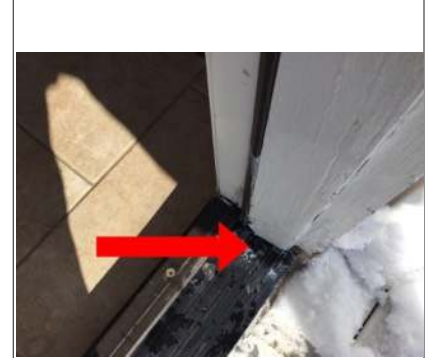
Back needs painted to prevent wood rot.

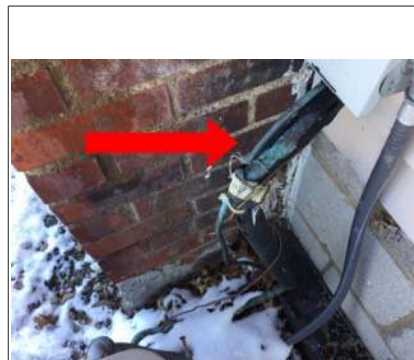
Damaged/Missing insulation recommend replacing insulation

Needs new insulation installed

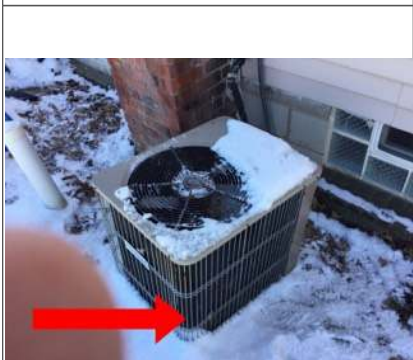
Condensing unit not level, recommend re-leveling unit

Needs to be leveled

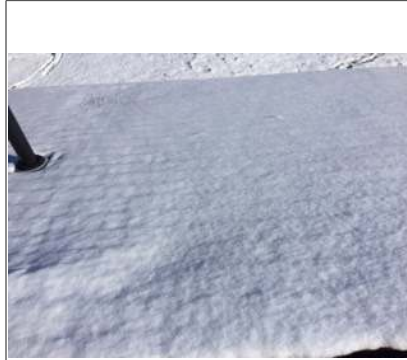
South side of roof covered with snow not able to complete the full inspection of the roof.

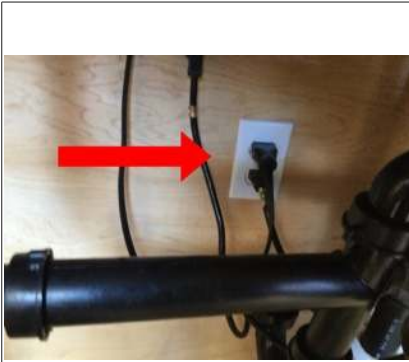
Non-GFCI circuit - Recommend that GFCI's are installed anywhere near a water source to prevent the possibility of shock. GFCI's should be installed in the following locations: kitchen, bathrooms, garage, laundry room, basement, outside locations.

Receptacle for the garbage disposal needs replaced with a GFCI by a licensed electrician.

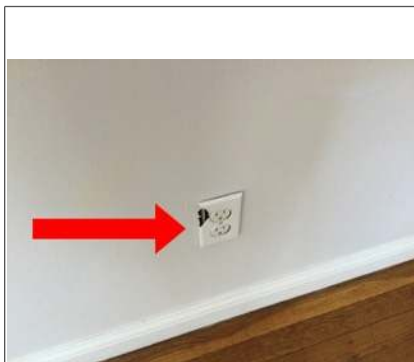
Receptacle cover needs replaced

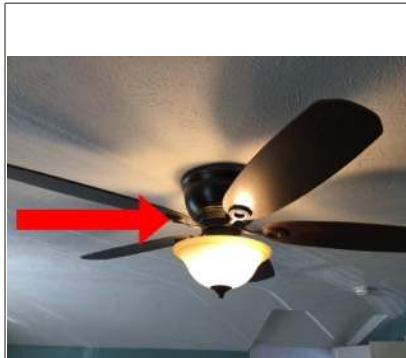
Fan does not work, need repaired by a licensed electrician

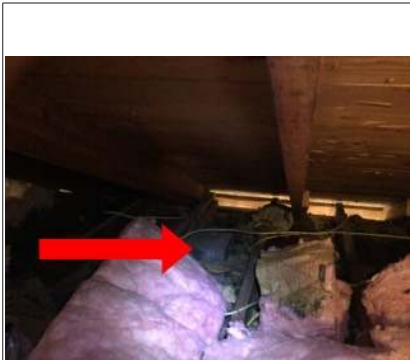
Bathroom exhaust fan needs to vented outside of the attic by a licensed contractor

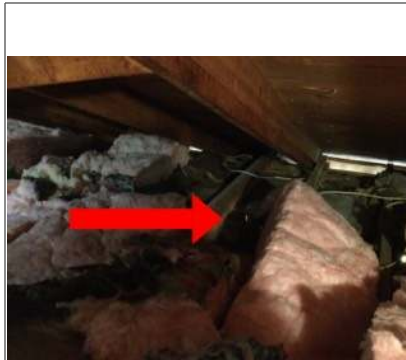
Need more insulation installed in attic

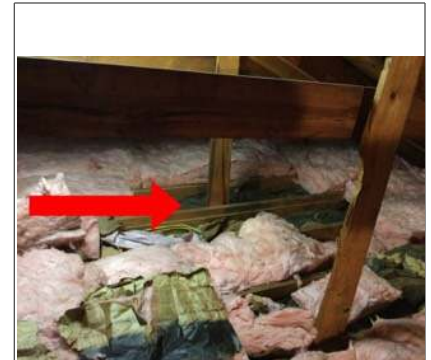
Needs more insulation installed in attic

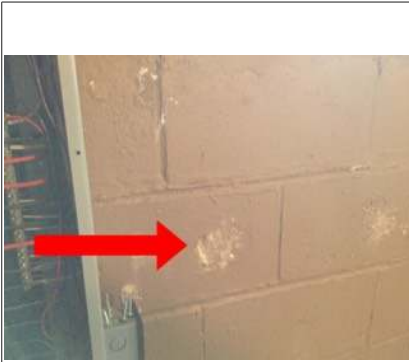
Comments Moisture present recommend monitoring

Water stains present, Efflorescence on walls from water intrusion in several places throughout basement. Recommend improving grading on outside walls to possibly improve water intrusion problem. Downspouts near these areas are many times found to be a contributing factor also. However, to completely alleviate moisture concerns, a waterproofing contractor would need to evaluate.

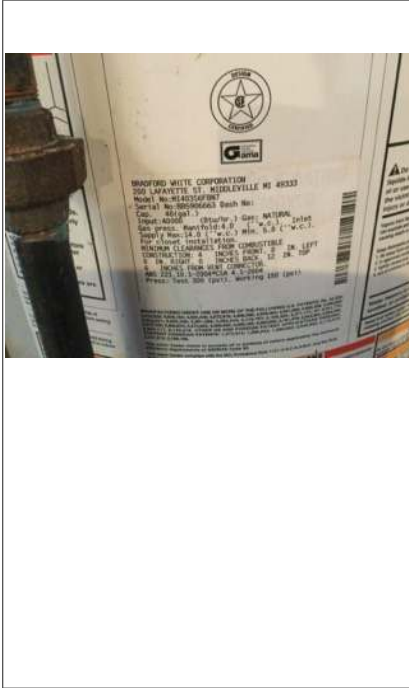
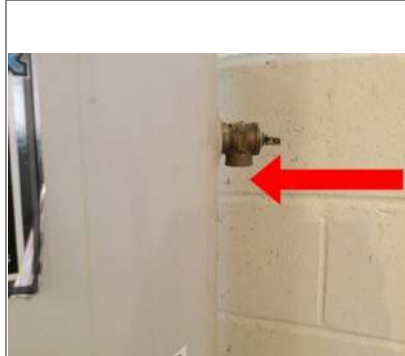
Comments Temperature-Pressure relief valve extension should be 4"-6" off of the floor - this is a Safety Concern.
Water heater is near the end of life and would budget a replacement unit.

T P R (temperature pressure relief) valve overflow pipe was too short or missing as compared with today's standards. Recommend extending to 6" above the floor to enhance safety function. Client should consult a licensed plumber for additional information.

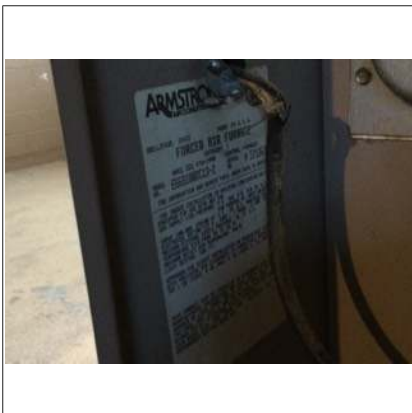
Comments Furnace was marginal and aging, unit was nearing end of its useful life.

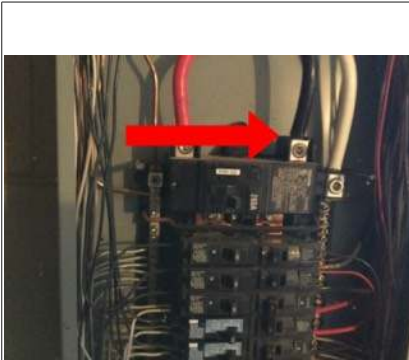
Alumni wire- recommend an anti-oxidant material be applied by a licensed electrician to wires and / or main terminal lug connection to reduce rust, corrosion or oxidation of exposed wires.
